RIVERSIDE OXBOW FORT WORTH, TEXAS

CHAPTER 2 STUDY AREA DESCRIPTION EXISTING AND FUTURE CONDITIONS

RIVERSIDE OXBOW STUDY AREA

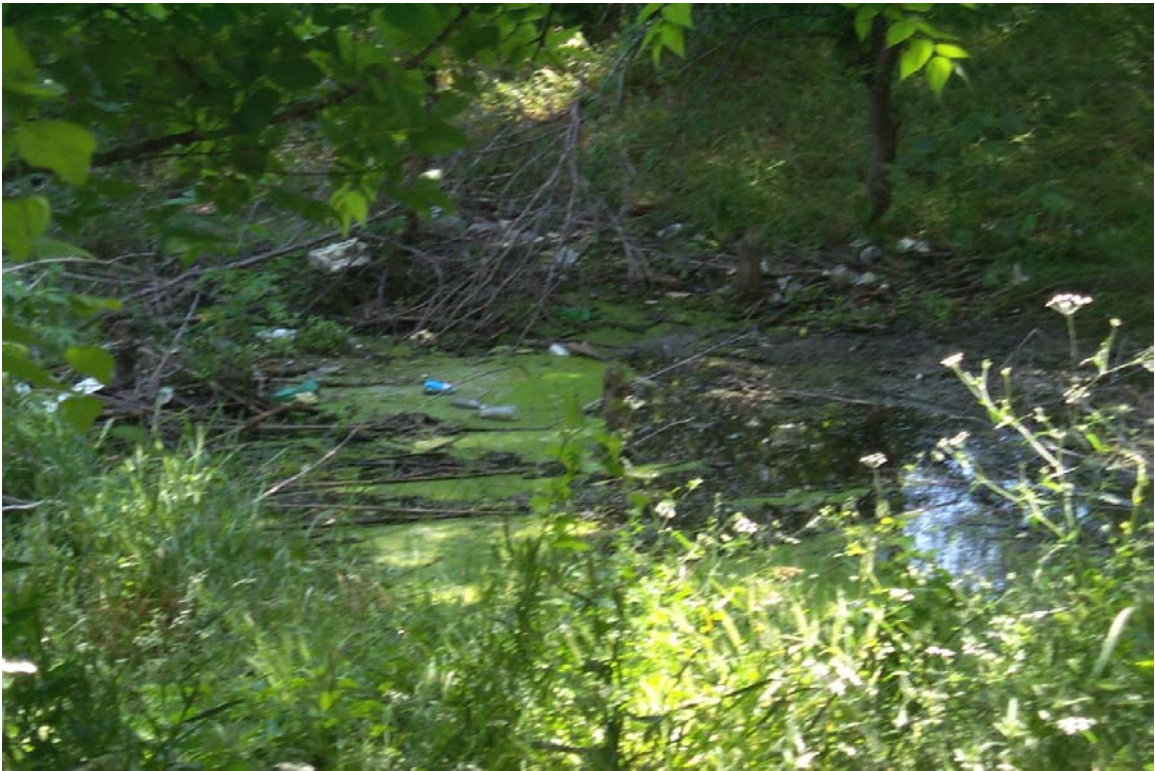
Photograph 1. Oxbow channel.

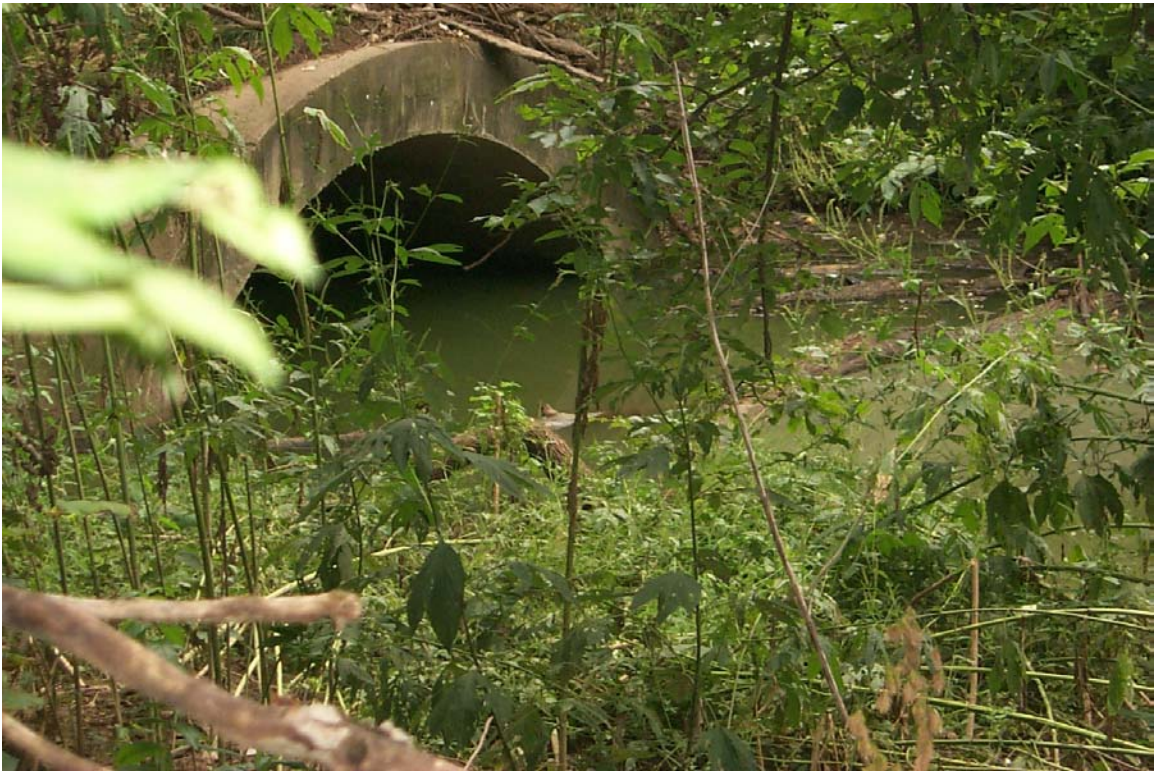
Photograph 3. Upstream end of oxbow culvert at Beach Street.

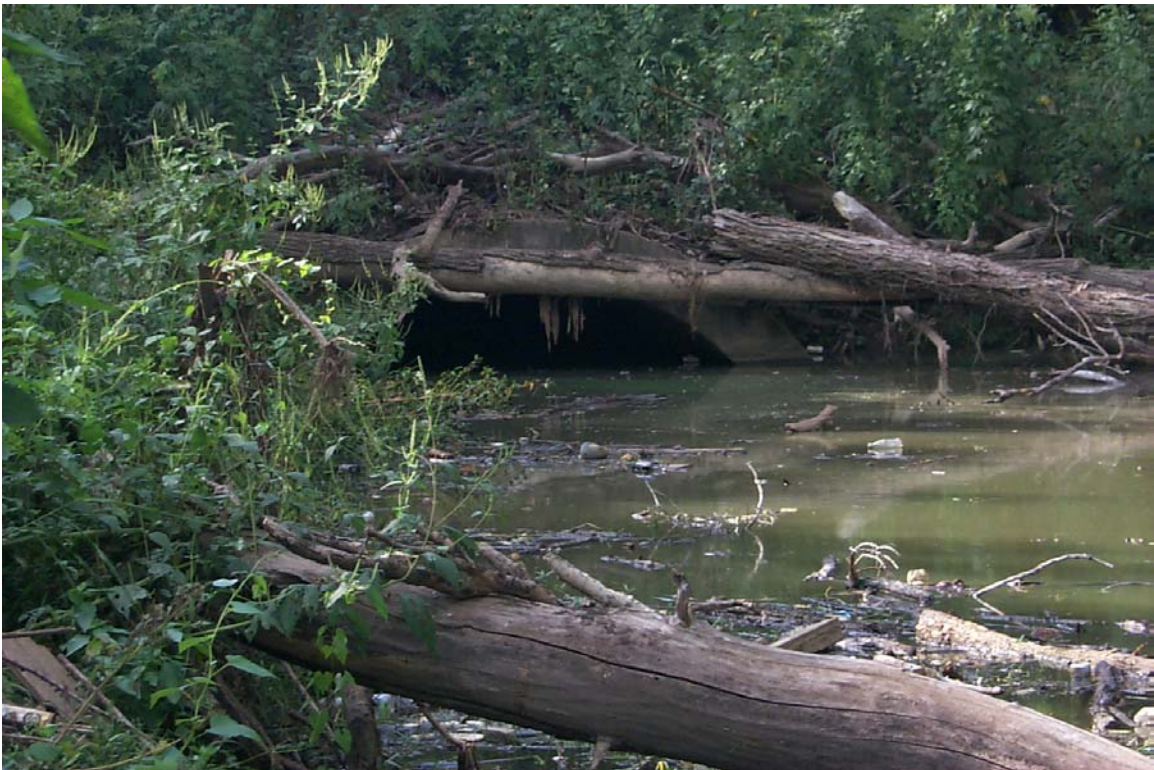
Photograph 4. Downstream end of oxbow culvert at Beach Street.

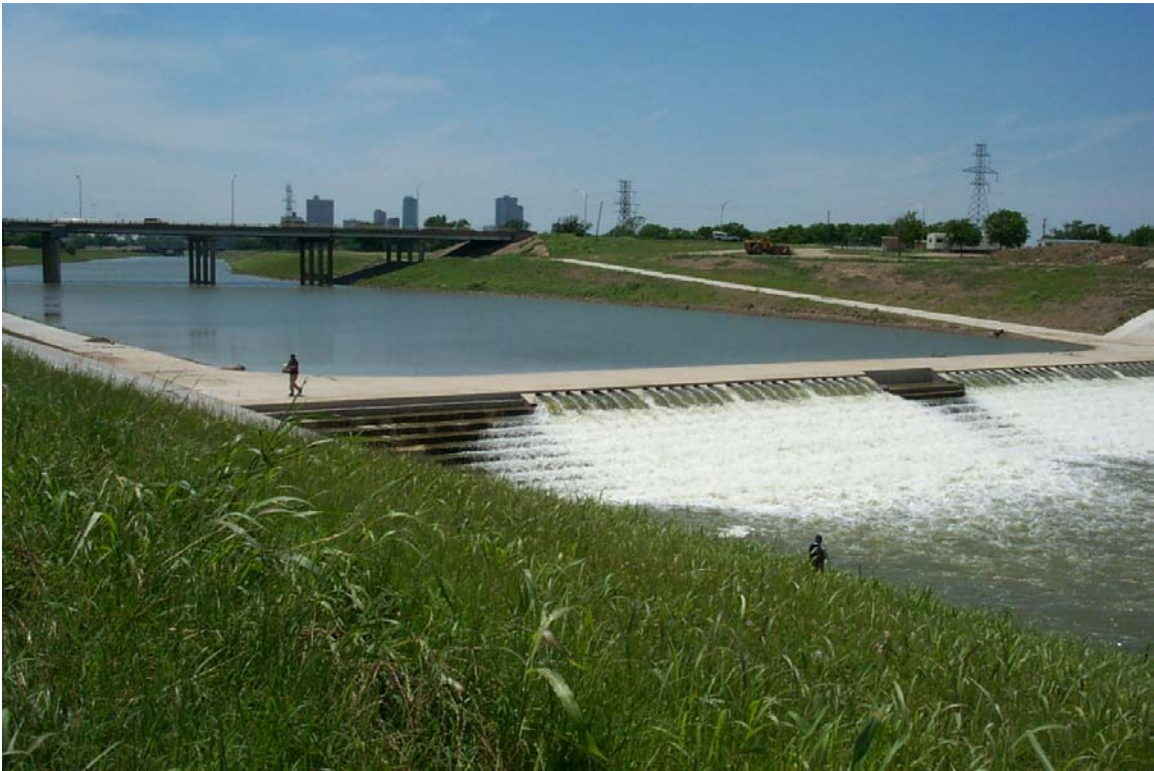
Photograph 7. Low water dam downstream of Beach Street.

Aquatic Resources. The aquatic resources in and adjacent to the Riverside Oxbow study area include two low water dams constructed to hold more water at specific points along the river channel. These dams are the 4th Street dam located just upstream of the study area and the new Beach Street dam located within the study area river reach. During site reconnaissance for the existing conditions phase of this report, it was observed that one of the major limiting factors for aquatic habitat quality in the study area was the lack of vegetation along and overhanging the rivers edges. This overhanging and bank vegetation provides food sources, shade, cover, and reproduction sites for multiple numbers of aquatic species, including invertebrates, fish, waterfowl, and shore and wading bird species. Reconnecting old oxbows to the main channels and adding low flows through these old river meanders was identified by the study team as a way to improve the quality and quantity of aquatic habitat in the area by providing this type of bank and

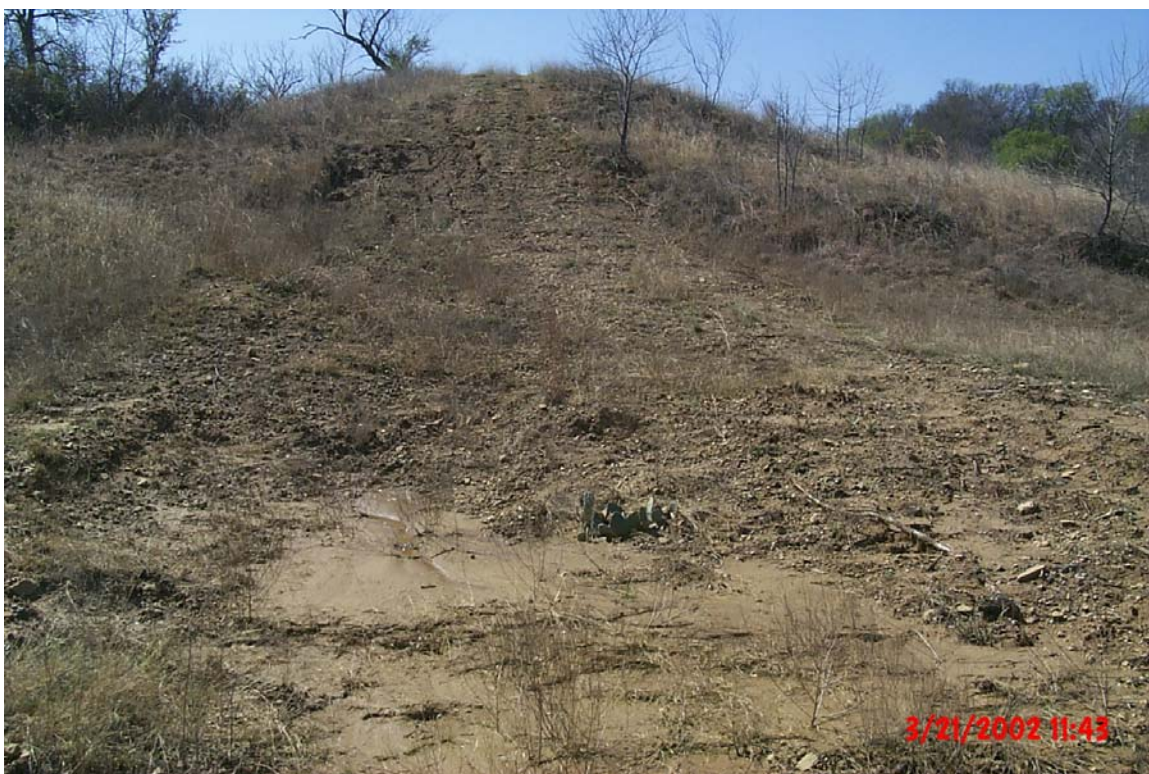
Photograph 12. Erosion from off road vehicle track following rain event.

While steps have been taken over the years to reduce disturbances to the Tandy zone, especially the parklands, there are still signs of erosion. Most of the erosion appears to be the result of illegal usage of the area by off road vehicles and random pedestrian hiking and biking trails that have damaged the vegetation that helps to stabilize the slopes. On the slopes and upland areas, these areas of damaged vegetation provide locations for runoff following rain events. This runoff washes additional soil and vegetation from the hills further exacerbating the problem and, over time, the soil on these slopes sloughs off and the problem magnifies (see Photograph 12). The existence of numerous riparian fingers with associated draws and rivlets in this zone that directly connect to the West Fork of the Trinity through a series of culverts under IH-30 mean that this soil quickly makes its way into the river causing increased sedimentation and turbidity and reducing the quality of the aquatic habitat. Photograph 13 depicts one of the narrow rivlets within the Tandy zone and photograph 14 shows the sedimentation that is occurring in the river channel just downstream of some of the culvert outfalls connecting the Tandy zone to the West Fork of the Trinity River. In addition to increasing sedimentation, the slope erosion and the encroachment of invader species in this zone, both in the understory vegetation of the bottomland hardwoods and in the native prairie grasslands, diminish the terrestrial wildlife habitat value of the area.

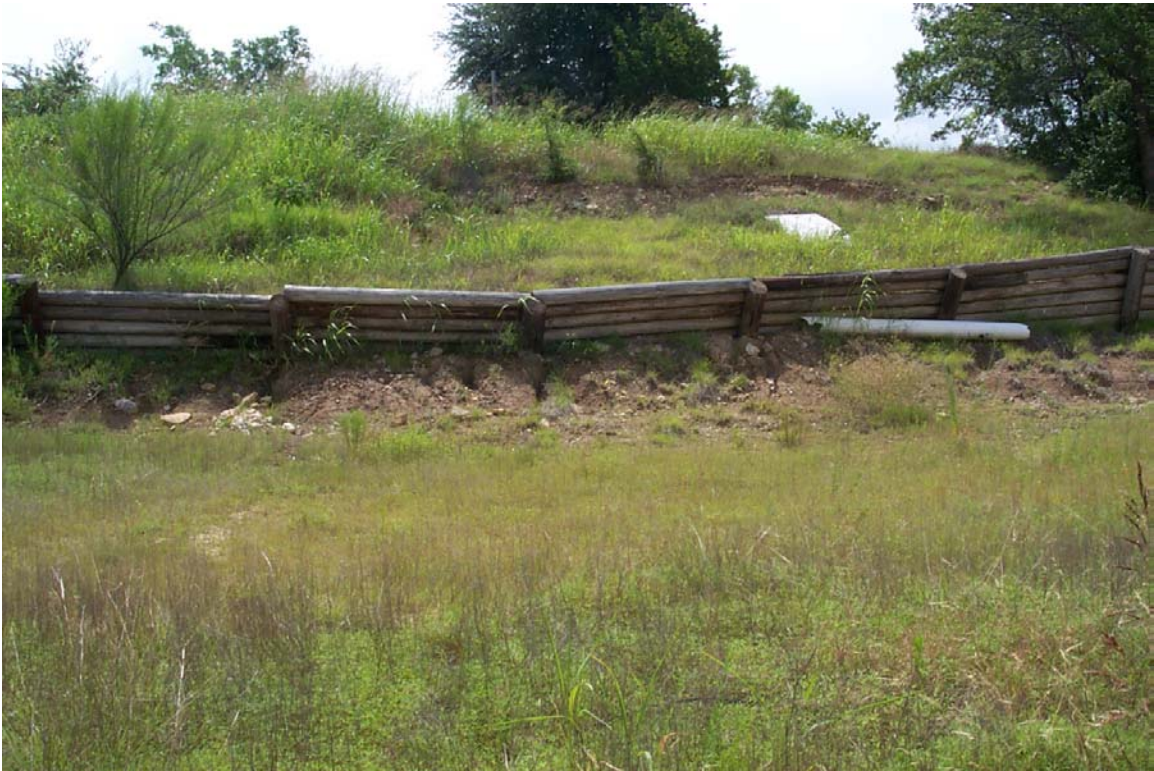
Photograph 15. Bulkheading and erosion on slope below restaurant slab.

On the private land adjacent to Tandy Hills Park, the erosion damage has been much more severe. A restaurant, once located on top of a hill between the two areas, has been removed but considerable disturbance in the form of the slab, parking lots, and bulkheading to protect the foundation remains (see Photographs 15 and 16). Other slope alterations in the vicinity and trash dumping at the end of the cul-de-sac access have decreased habitat quality of the area. Photographs 17 and 18 show a large area of disturbance from what appears to be an attempt to make an access route, which has significantly impacted the vegetation in the western end of the zone. Erosion and the

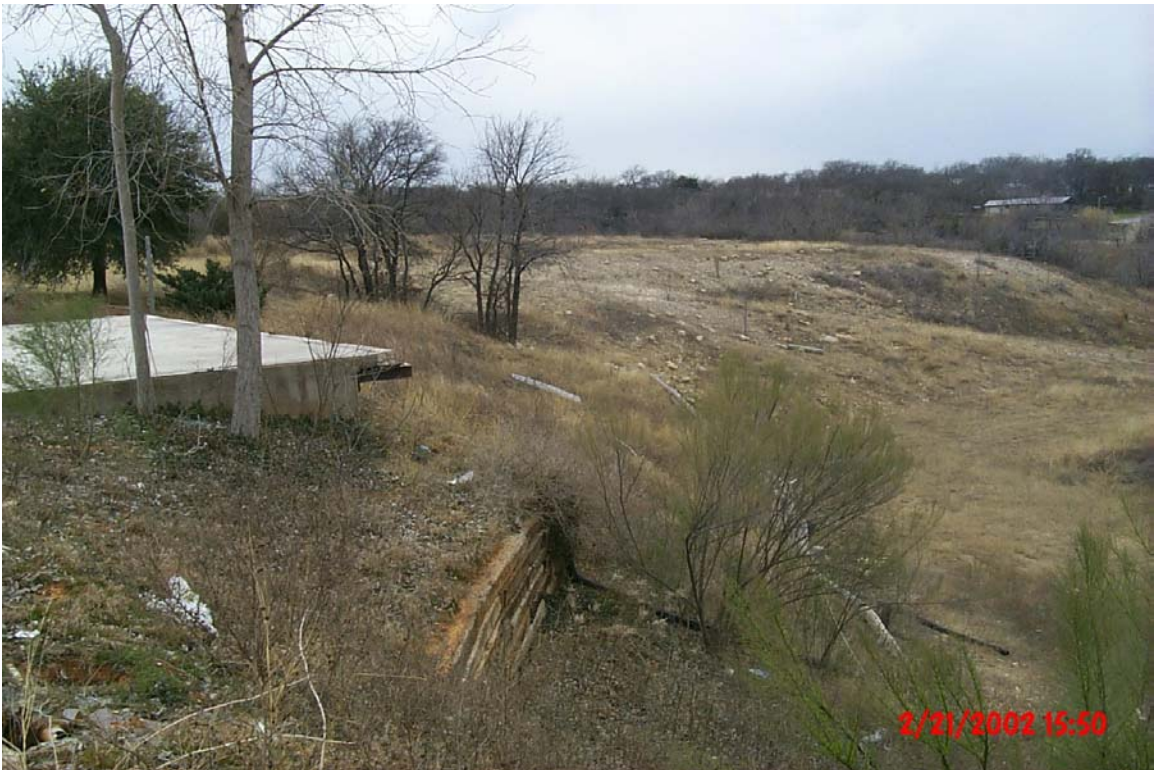
Photograph 16. Part of restaurant slab, bulkheading, and disturbed areas.
